# **Geomorphological Evaluation of Weathering on the Marine Scarp of Um Sid Plateau in South Sinai, Egypt**

**Manal Samir Shalapy Metwaly\***

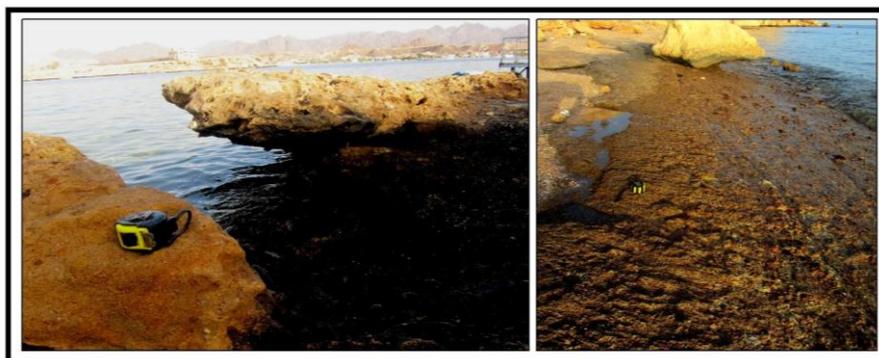
**Figure 2.** The appearance of limestone formations with a dark colour reflecting the interaction between the sea water and the minerals constituting the rocks.

the limestone formations which constitute the study area and which appear in a dark colour reflecting the interaction of the sea water with the minerals constituting the rocks (Figure 2).

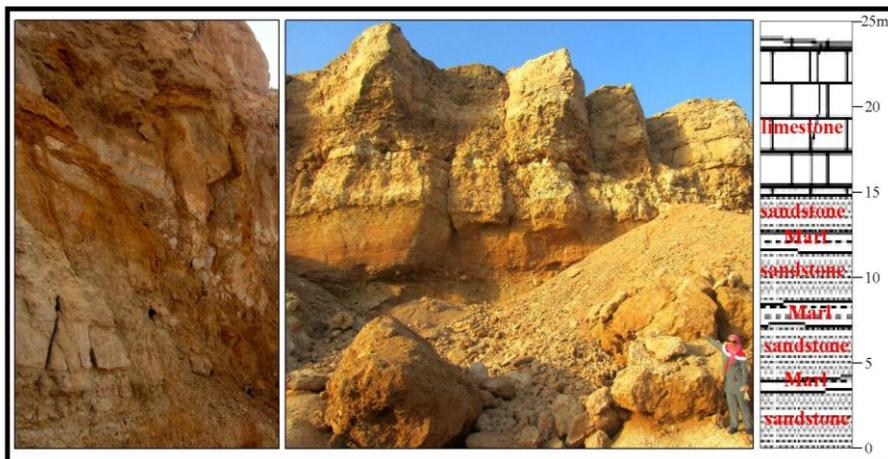
**Figure 3.** The geological formation of the marine scarp of Um Sid Plateau.

The marine scarp of Um Sid Plateau consists of two units; the first lies in the upper layer and consists of coral limestone, the second lies in the hazarder layer and consists of sandstone with Marl interventions (Figure 3). It is affected by several modern faults which originated at the end of the Paleocene age and whose direction is the northern east and the southern west. As to the ancient faults, they were formed in the Oligocene age and most of them permeate through the sandstone layers and the upper layers are not affected by them (Abd Eltawab, 2012).

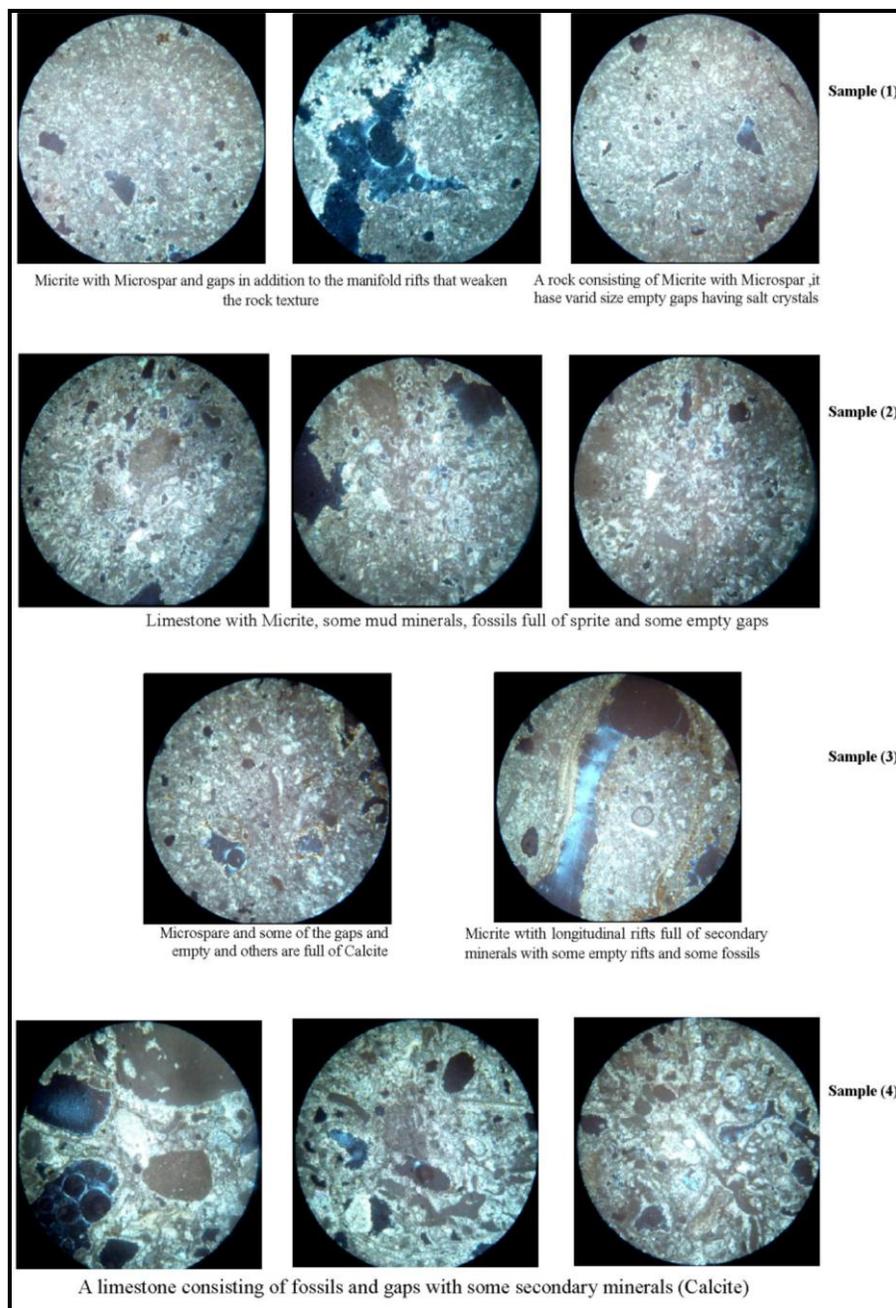
**Figure 4.** Variation in the mineral structure of the rocks of the marine scarp of Um Sid Plateau.

The analysis of the samples of the Thin-Section optical microscope with a magnification power of 400X (Figure 4) reveals the spread of limestone consisting of the Micrite in the samples of the scarp. This limestone responds to weathering greatly since these samples are full of fossils, gaps, manifold rifts with salt crystals. This is beside the Calcite mineral, the Micrite, the Microspar and the fossils coloured with Sparite especially in the south and west of the study area.

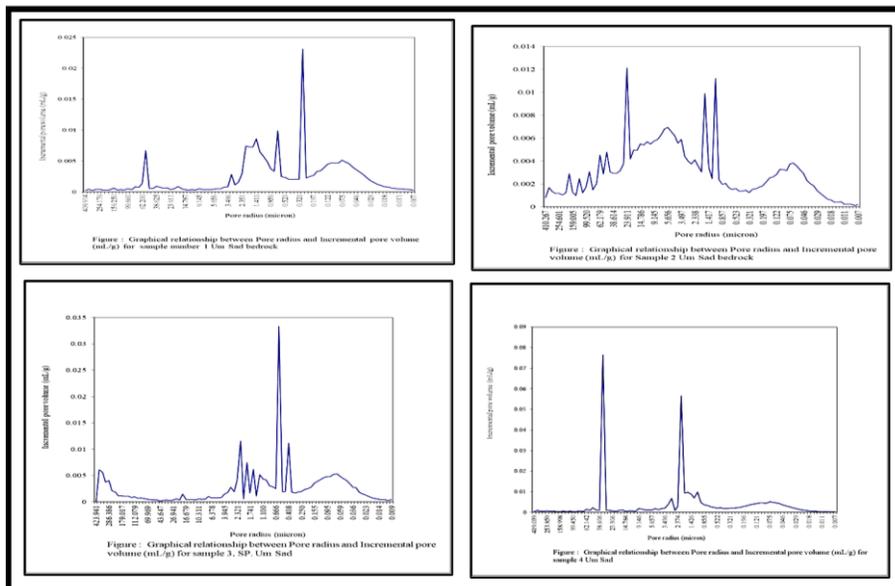
**Figure 5.** The percentage of the diameters of the rock pores in the study area.

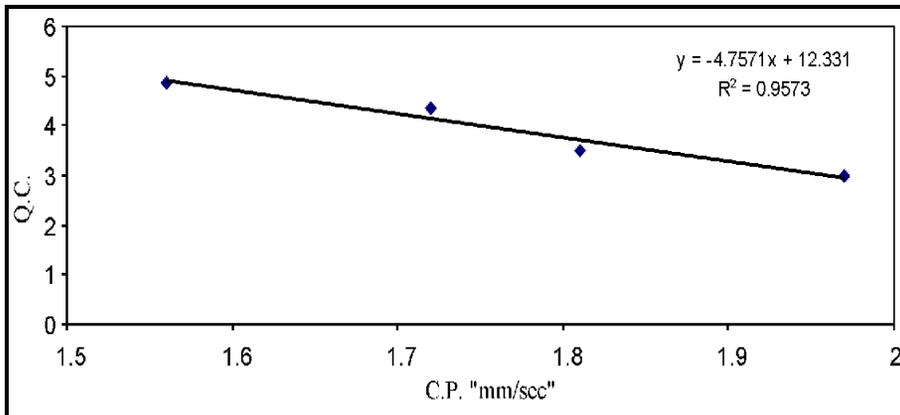
**Figure 6.** The degree of relatedness between the speed of the ultrasound waves and the force of internal friction of the rocks of the marine scarp of Um Sid Plateau.

The study relied upon the method of the ultrasonic pulses (Table 6) to confirm the percentage of porosity inside rocks. This method relies on measuring the velocity of ultrasonic waves Cp and the internal friction force QC to clarify the degree of weathering in each sample since there is a contrastive relationship between them (Figure 6).

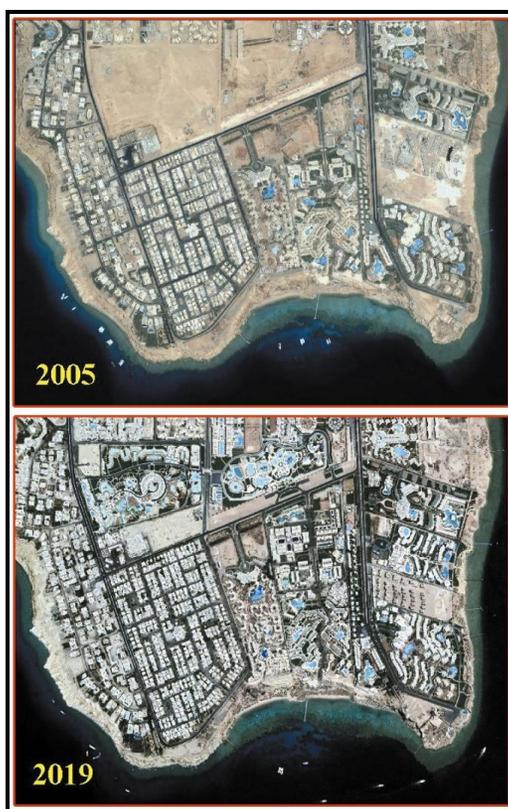
**Figure 7.** The spread of touristic resorts, swimming pools and gardens on the surface of Um Sid Plateau.

Human factors play a distinctive role in the activeness of the weathering process and its effect upon the marine scarp of the Plateau. The Plateau is distinguished with its unique touristic location to Sharm El Sheikh City and the attraction of tourists. This explains the construction of villas with their gardens, swimming pools and touristic resorts (Figure 7). Both the Excessive irrigation of gardens; which is the main characteristic in touristic areas and the sewage leakage into the Plateau-as registered in several locations (Figure 8) have led to the growth of plants inside them especially on the marine scarp (Figure 9). This growth has a mechanical effect as it helps in expanding the joints and cracks, therefore disintegration of rocks. This growth has a chemical effect as it forms organic acids from the rotten plants. These acids have a great effect upon the dissolution of some elements (Saber, 2017). This led to the increase in the porosity, the widening of cracks and joints more and more in the marine scarp so that rocks become increasingly weak, to end in disintegration and decomposition.

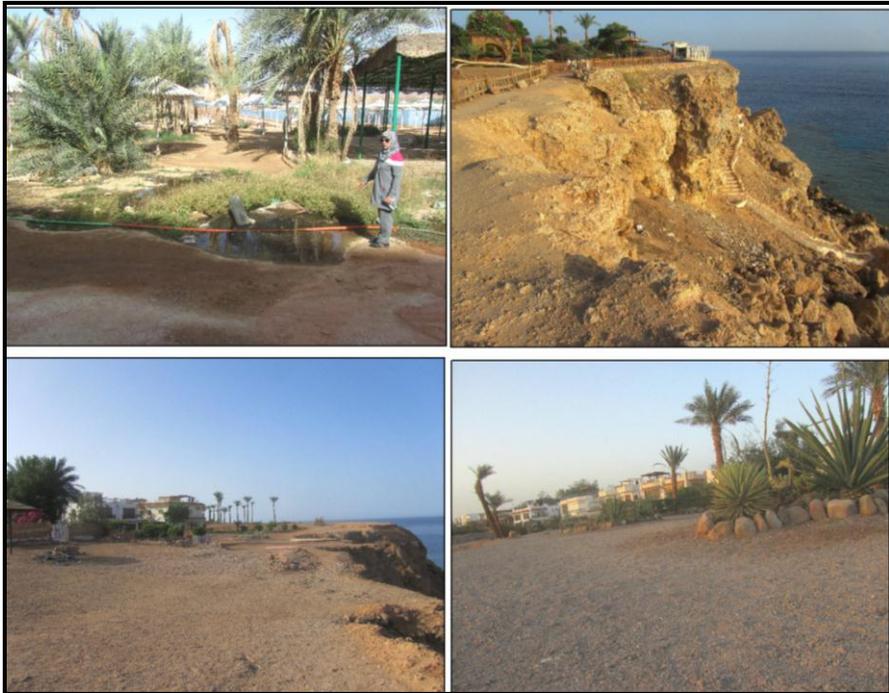
**Figure 8.** Human activity on the surface of Um Sid Plateau.

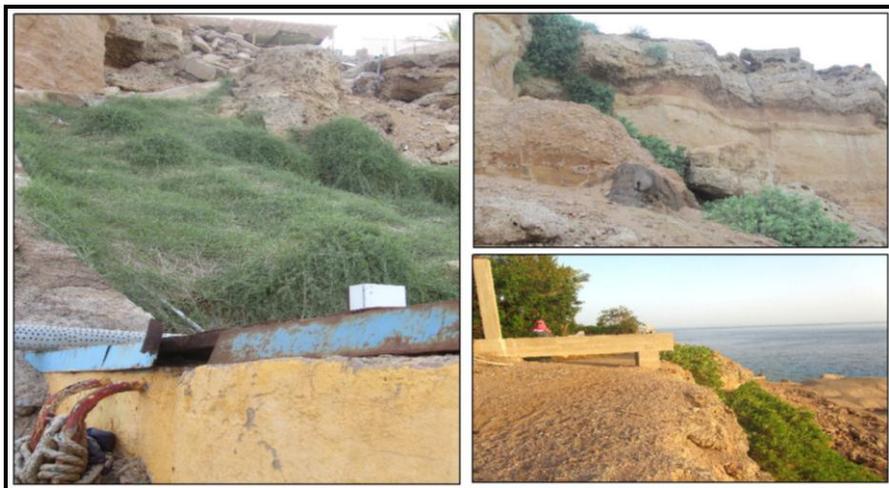
**Figure 9.** The growth of plants inside the joints and cracks which helped in the dissociation, disintegration and decomposition of the marine scarp rocks of Um Sid Plateau.

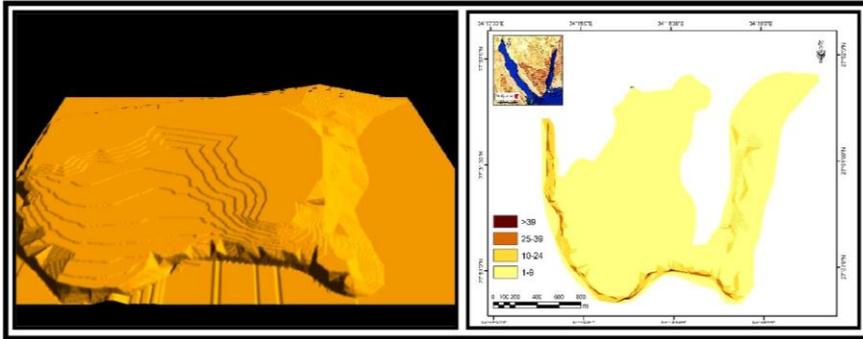
**Figure 10.** The Slopes degrees and relief model image of Um Sid Plateau surface.

The problem has been worsened with the terrain properties of the Plateau surface since Figure (10) indicates the plainness of its surface evenness as the percentage of the hazard slope areas has reached 94.2%. This has helped in the increasing and quick growth of human activity on the surface of the Plateau and in the increasing of the water lakage process.

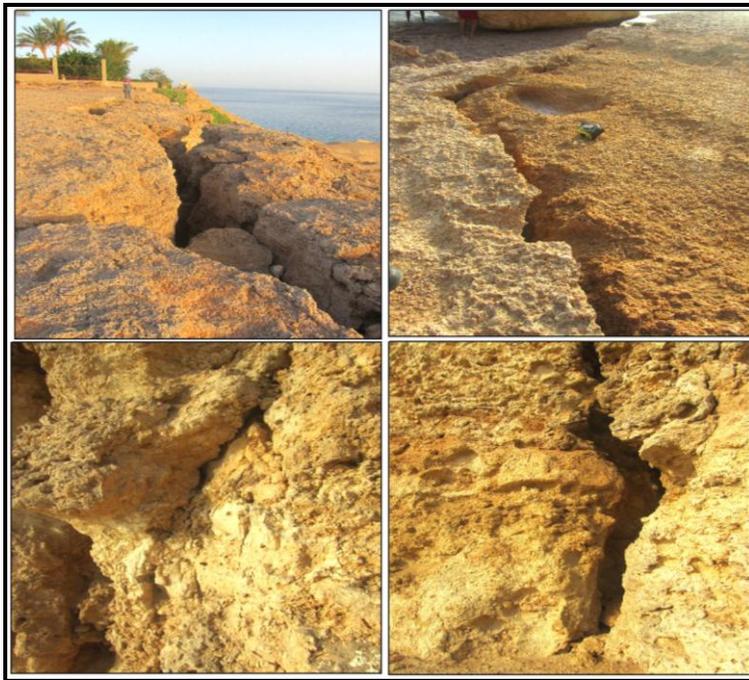
**Figure 11.** Joint system in the rocks in the study area.

The constituents of the Plateau especially the scarp were dissolved due to the correlation of the natural factors including the spread of limestone and Marl in Um Sid Plateau with the spread of cracks and joints inside it and the evenness of its surface and the human factors including the leakage of irrigation water and sewage as well as the growth of plants inside rifts. The field study revealed the spread of cracks and joints which appeared obviously inside the limestone formation and it ranged between medium and strong especially in the south of the scarp (Figure 11). Generally, joints and cracks are characterized with the existence of several directions whether vertical or horizontal or both, which is the most prevalent. Besides, the degree of intersection is medium to high with big depths.

The persistence of most of these joints ranges between 10 and 20 m. Most of them have steep dip angles varying between 80 and 85°. The joint opening ranges between 0.5 and 10 cm with rough undulated surfaces (Abd El-Tawab, 2012)

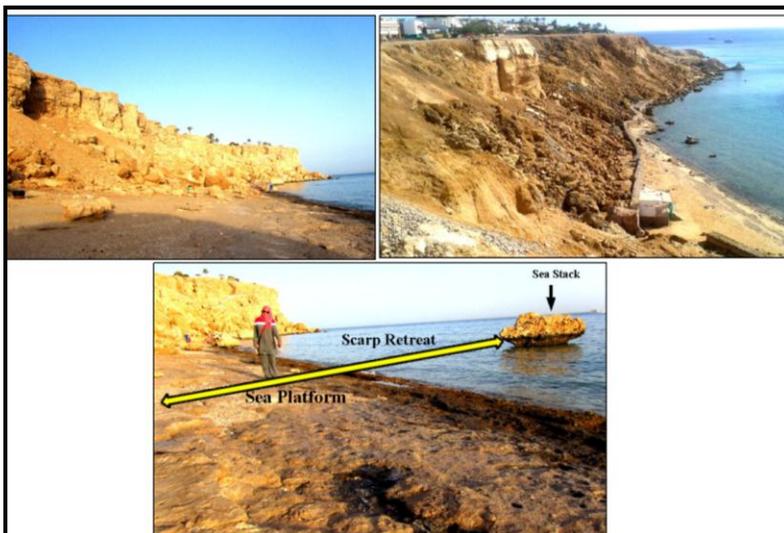
**Figure 12.** Collapses and rock falling and retreat of the marine scarp and the formation of a marine platform in the study area.

Accordingly, the phenomena of mass separation, shattering and granular disintegration becomes spread so that the size of the dissociated masses increases, sloping increases, the surface of the scarp retreats and several geomorphological phenomena become spread such as holes, cavities and granules (Figure 12).

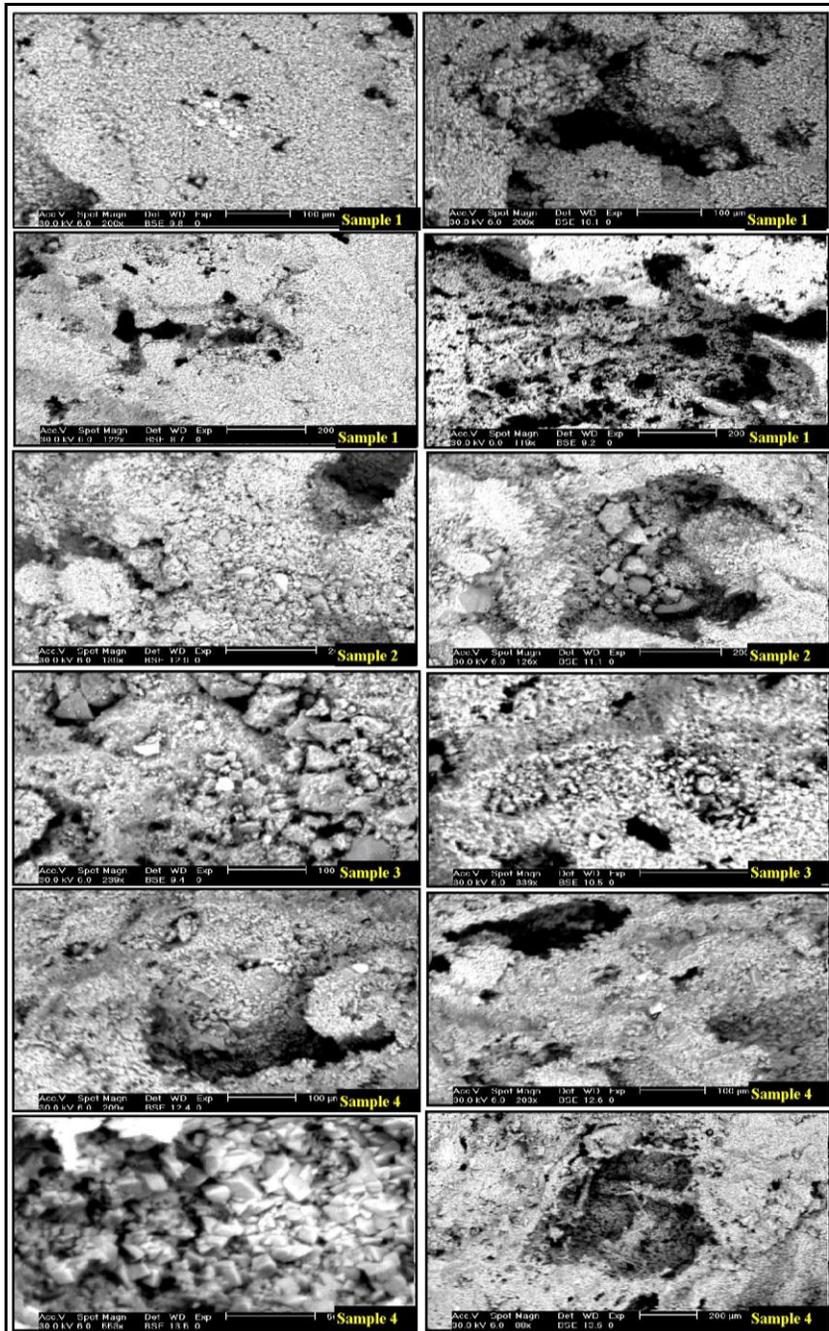
**Figure 13.** The Weathering Features inside the rocks of the marine scarp of Um Sid Plateau (Using the Electronic Microscope).

- **The First Sample:** It is located to the west of the marine scarp. It consists of limestone that consists of Microspar 5-10 micron; It is full of some fossils, Sodium Chloride salts (the white parts), gaps full of sparite, varied size gaps that are entangled and empty as a result of weathering; taking a round and linear shape and it helped in gathering humidity and salts inside it so that the rock became weakened and disintegrated.

- **The Third Sample:** It is located to the east of the marine scarp. It is a Microspar with middle size gaps full of sparite and minute fossils (Foraminifera) and it consists of Micrite (soft calcareous substances) in addition to the separation of granules of rocks with the size of 50 micron.

- **The Fourth Sample:** It is located to the east of the marine scarp and it consists of Microspar, sparite, giant gaps with variant shapes having sulfate salt crystals and some Halite along with some connected rifts. In addition, it consists of big size sparite with huge gaps having Sulfate salt crystals with some Halite and some minute rifts.

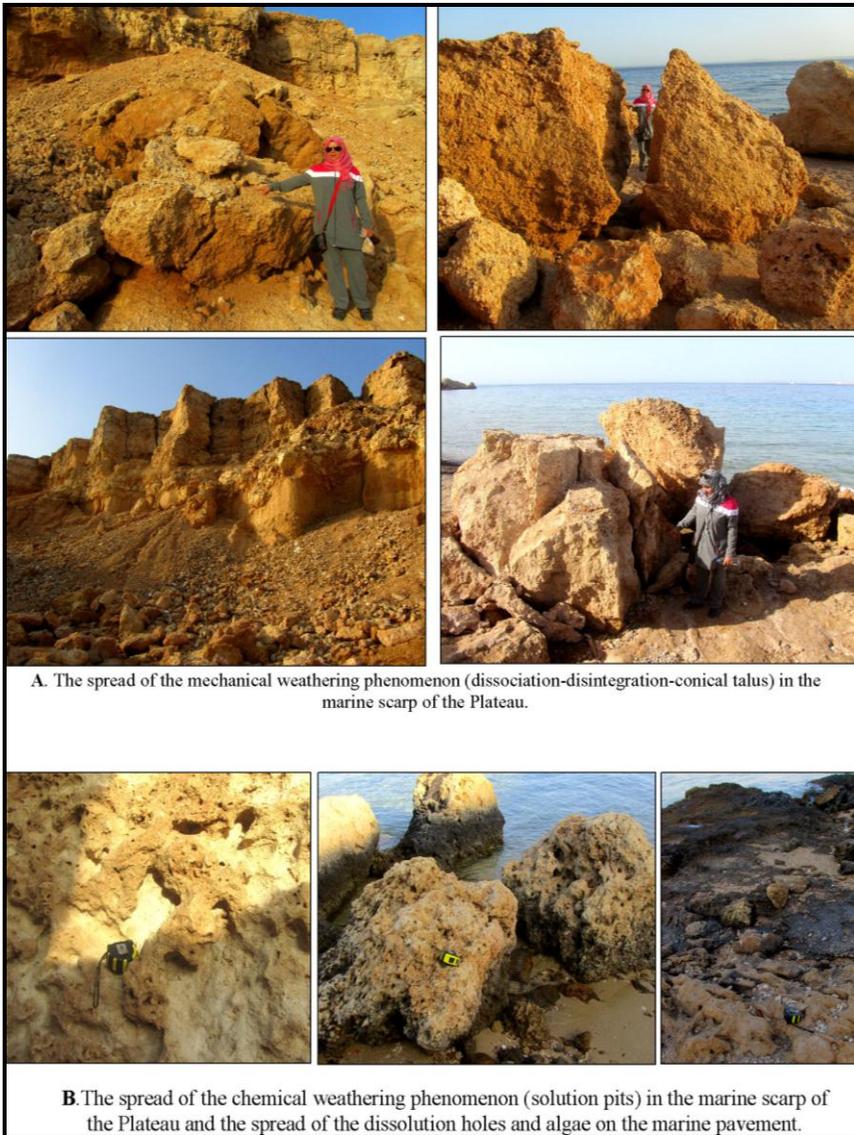
**Figure 14.** Some of the phenomena resulting from weathering in the marine scarp of Um Sid Plateau.

It is represented in the break of the body of the rock and its division into masses along the extension of joints and separation surfaces which rupture its parts. Such dissociation is widespread in the marine scarp of Um Sid Plateau (Figure 14); which is an indication and proof of the strong weathering especially the mechanical because of its consisting of limestone and the spread of streams among these masses helping to collect the surface water or sea water or irrigation water inside them causing their collapse. No part of this scarp is free from this phenomenon; the main reason behind this is the system of the horizontal and vertical joints and the constituents of the limestone. However, there is an obvious increase in the south of the scarp. In most cases, fraction takes place nearly in the middle of the mass so that small rocky masses appear (Figure 13). The maximum length of these rocks in the study area ranges from about 0.50 to 3.0 and their height, which vertically extended upon the length extension, ranges from 0.5 to 2.5 m.

The different weathering processes whether mechanical or chemical have a main role in the emergence of marine Platforms in the study area because of the weakness of the marine weathering factors especially the hazard waves. Degradation and back word retraction of rock surface took place as a result of the succession of wetness and dryness, the dissociation, disintegration and dissolution of the limestone rocks that are spread in the rocks of the Plateau. They are spread along the marine scarp especially the southern side. The length of the marine Platform ranges between 3 to 120 meters and there are widespread solution pits and rock masses as well as the multicoloured algae (Figure 14).

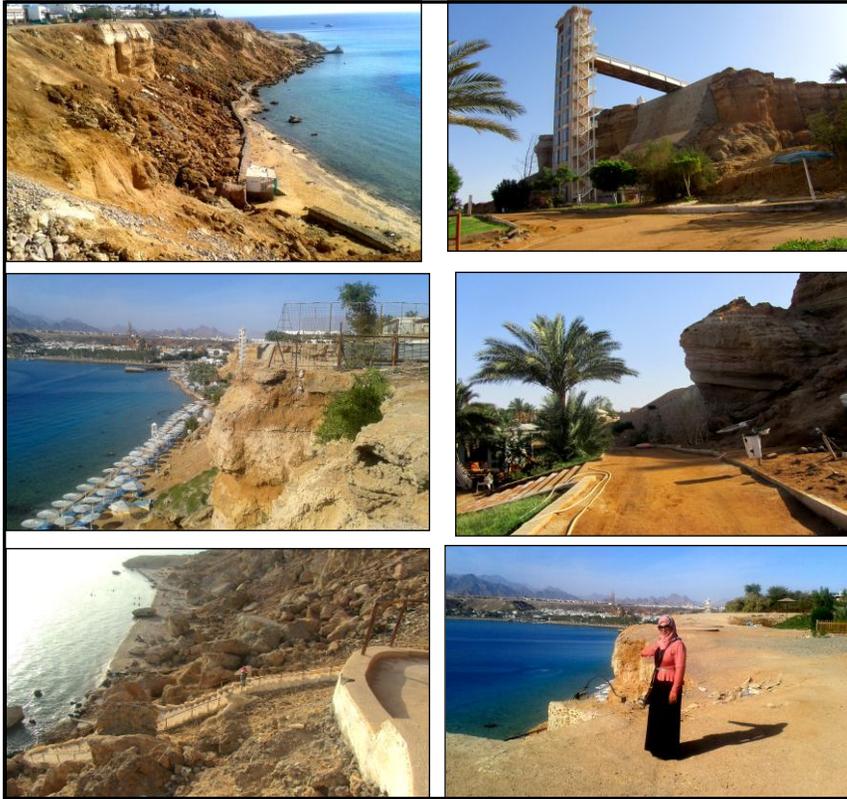
**Figure 17.** Several touristic activities are exposed to the hazard of rock falling from the marine scarp of Um Sid Plateau.

- **The Southern Scarp:** Its length is 1.6 Km where about 56% (0.9) of its total length is exploited in touristic activity. However, despite the exploitation of half of the scarp length, human activity in this area is in great hazard since this area is the most exposed area to the hazard of rock falling because of the extension of the activity to the scarp itself (Figure 17).

- **The Southern Scarp:** It is similar to the western marine scarp in the degree of hazard. Its length is 1.6Km where about 56% (0.9) of its total length is exploited in touristic activity. However, despite the exploitation of half of the scarp length, human activity in this area is in great hazard since this area is the most exposed area to the hazard of rock falling because of the extension of the activity to the scarp itself (Figure 17).

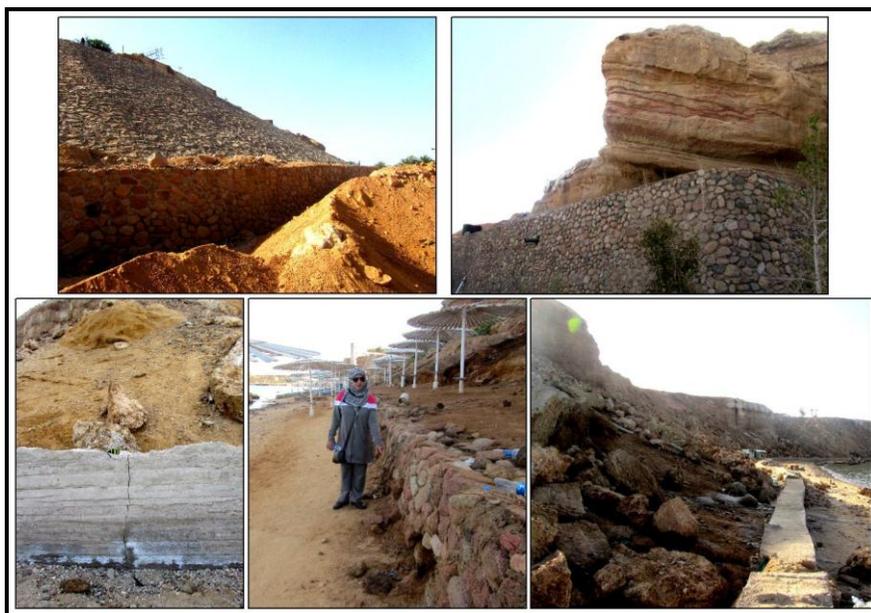
**Figure 18.** Some of the protection methods from the hazard of rock falling from the marine scarp of Um Sid Plateau.

The field study has registered a group of the protection methods from the rock fall hazard which results from the weathering action in the study area (Figure 18) as follows:

- Blocking walls from rocks and cement (There is a constructed part on the western side of the scarp). Its main purpose is preventing the arrival of the high tide to the bottom of the marine scarp. Besides, it serves as a blocking wall to prevent the masses and rock granules from reaching human activity.
- The existence of rock and cement lining for some of the scarp sides.
