# **Sabil Muhammad Ali in Al-Aqqadin, Cairo: A Study in Applied Geomorpho-Archaeology**

**Prof. Dr. Ahmed Ibrahim Mohamed Saber<sup>1\*</sup> & Dr. Amira Mohamed Al-Banna<sup>2</sup>**

The city of Cairo includes many sabils, and perhaps the most famous of them is Sabil Muhammad Ali in Al-Aqqadin, which was established in 1820 as a charity in memory of Muhammad Ali Pasha's son, Prince Tusun. The purpose of its establishment was to facilitate obtaining pure drinking water throughout the year, particularly when the Nile water level is low, and this has been done by storing water in a cistern under the tasbil room. It is considered one of the largest remaining cisterns in Cairo. It has recently been subjected to many violations, which led to an evident deterioration in its architecture as well as its cultural, historical and aesthetic value. This is mainly due to the negligence and the variety of factors that damage the stones used in building the Sabil, such as climatic conditions, groundwater, and wrong restoration. Accordingly, this led to limestone being affected by weathering, particularly salt weathering, which led to the spread of many manifestations of damage in Sabil Muhamma

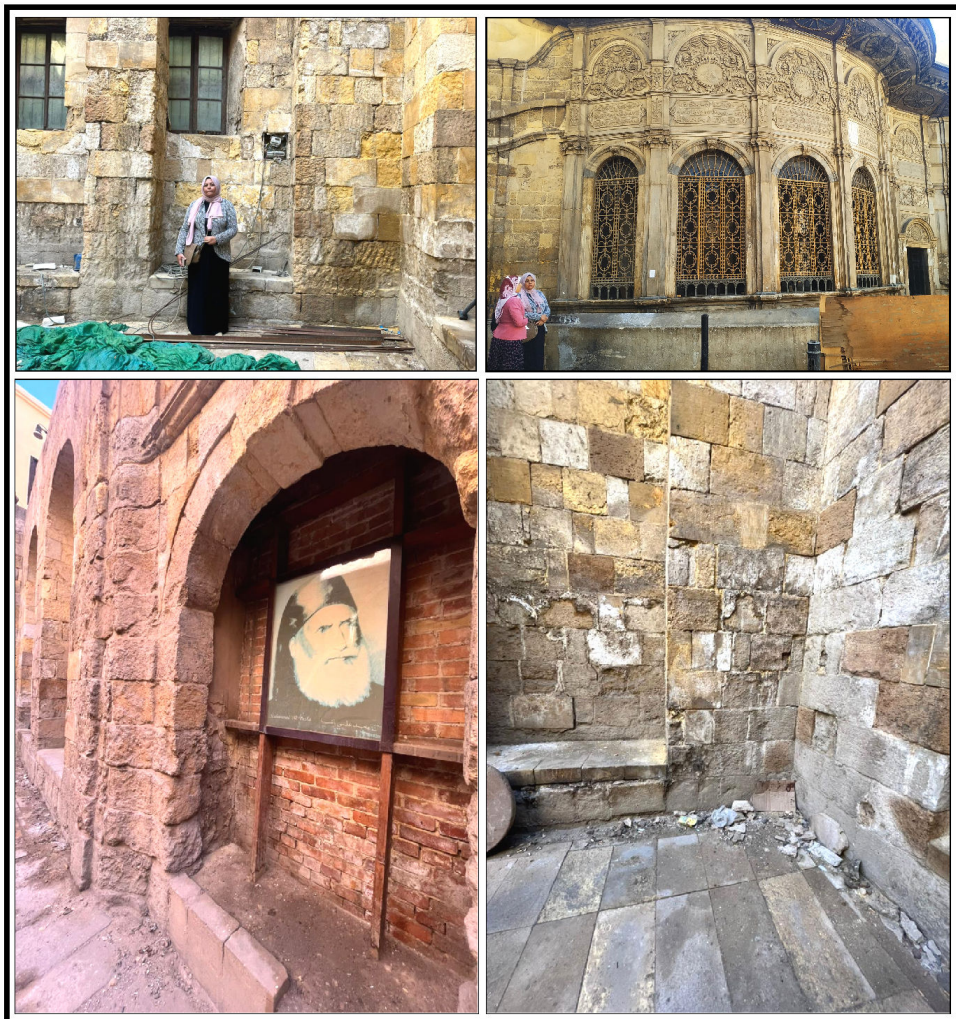
**Figure 1:** The Deterioration of the Architecture of Sabil Muhammad Ali

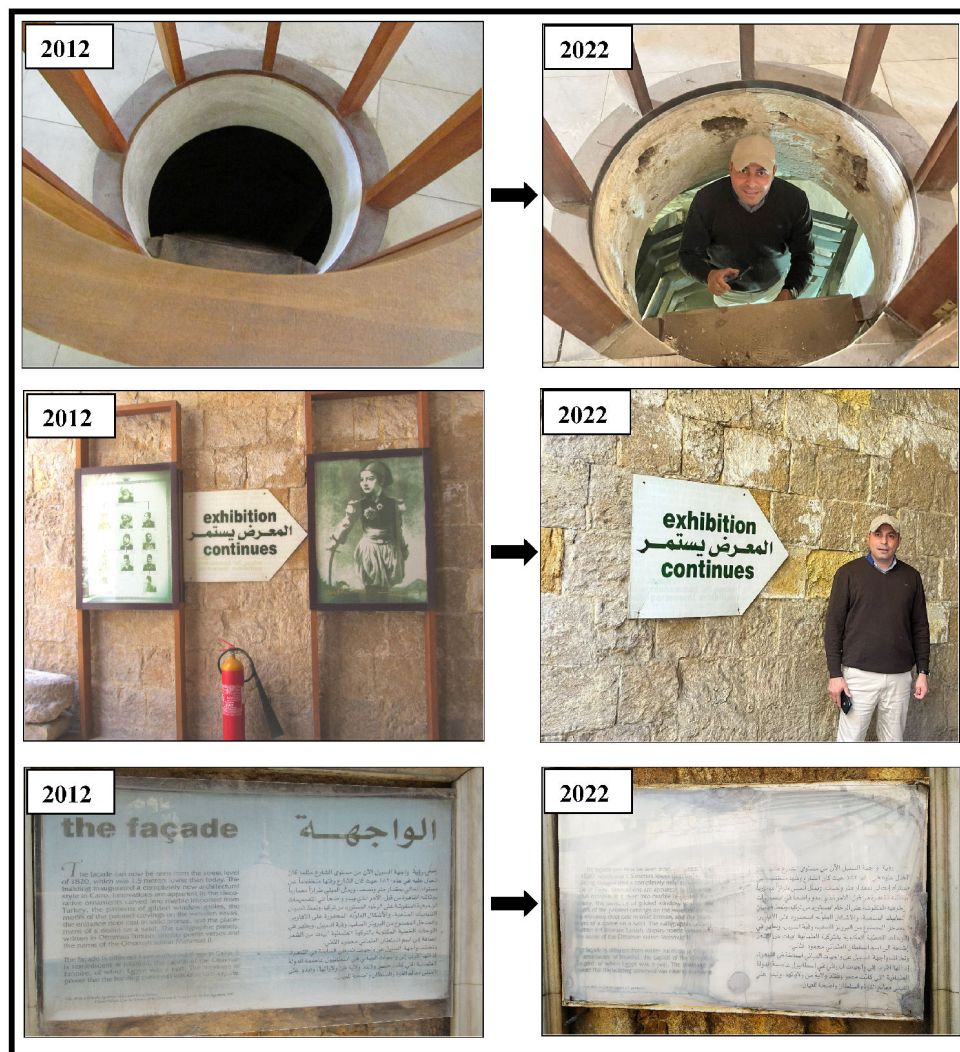
**Figure 2:** The Deterioration of the Cultural, Historical and Aesthetic Value of Sabil Muhammad Ali

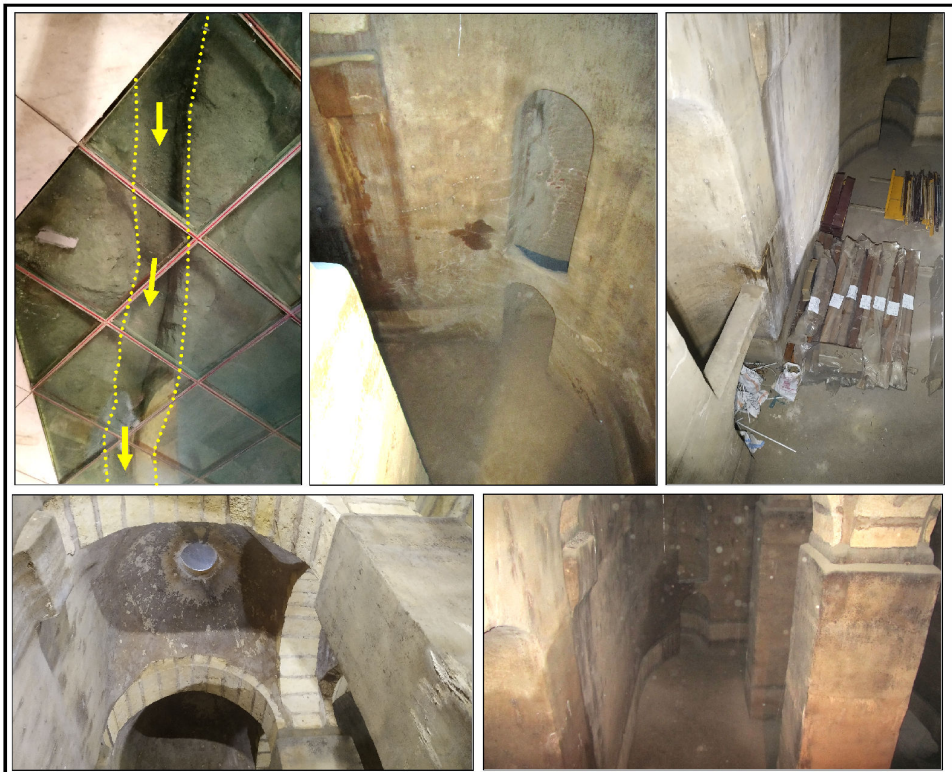
The water in Sabil Muhammad Ali is preserved in a huge cistern under the tasbil room, and it is one of the largest remaining cisterns in Cairo, with a depth of 9 meters and a capacity of 455,000 liters, sufficient to fill a million and a half cups of water. It is roofed with stone domes, and its walls are lined with waterproof mortar (Figure 6). It was fed with water by pipes filled by wheels on the Egyptian Gulf, which was penetrating the city at the time (Al-Sayed, 2021). However, the Gulf was neglected after the opening of the Suez Canal in 1869, the establishment of the Cairo Water Company, and the extension of pure water pipes to many neighborhoods in Cairo. Khedive Abbas Helmy II ordered it to be filled in, out of consideration for public health in 1898, and its location was transformed into a street called "Egyptian Gulf Street." In 1956, its name was changed to Port Said Street (Figure 7).

**Figure 6:** The Cistern in Sabil Muhammad Ali and the Channel for Water Transport from outside the Sabil to the Cistern

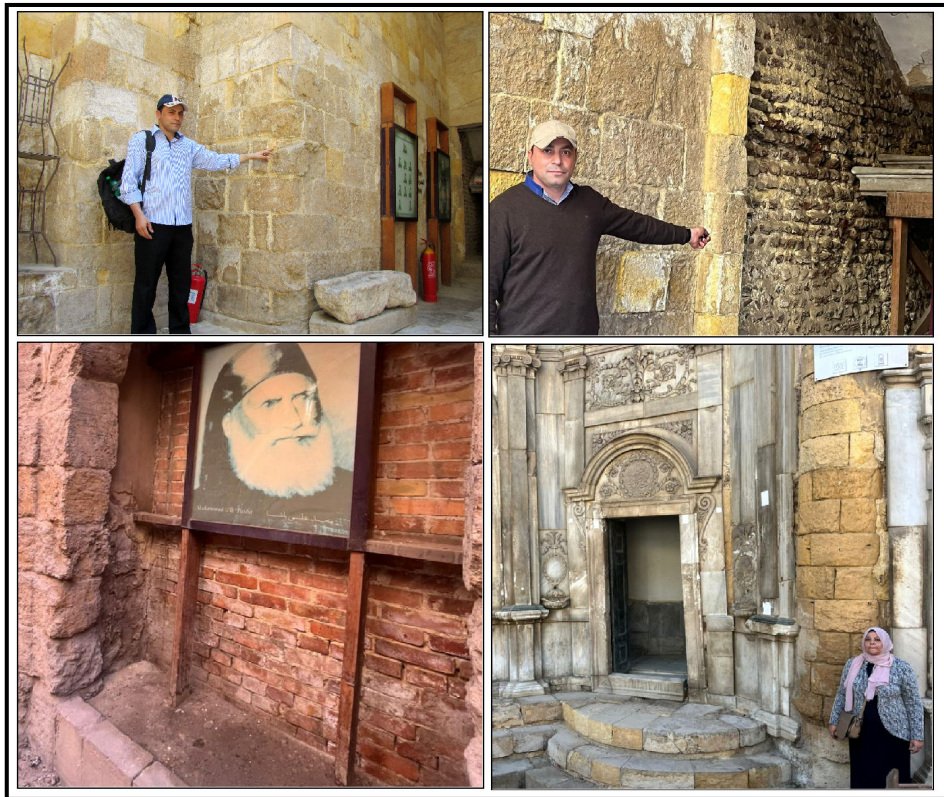
**3.1) Mineral composition:** Limestones were used in the construction of sabil Muhammad Ali as a basis for the building, in addition to red bricks and marble (Figure 8). The analysis of limestone samples by X-Ray indicates that the main component of limestone samples is calcium carbonate ( $\text{CaCO}_3$ ), which is considered the basic stone material, with a percentage exceeding 80.0%, noting the presence of a small percentage of quartz mineral ( $\text{SiO}_2$ ) ranging between 2.01% and 4.17 %. As for the chemical analysis of red bricks, it indicates that they contain quartz with the highest percentage of 31.2%. Hematite is also present in the sample in a significant proportion, and its presence with quartz along with orthoclase gives the red brick durability and strength (Darwish, 2007).

**Figure 8:** The Variety of Stones Used in the Construction of Sabil Muhammad Ali

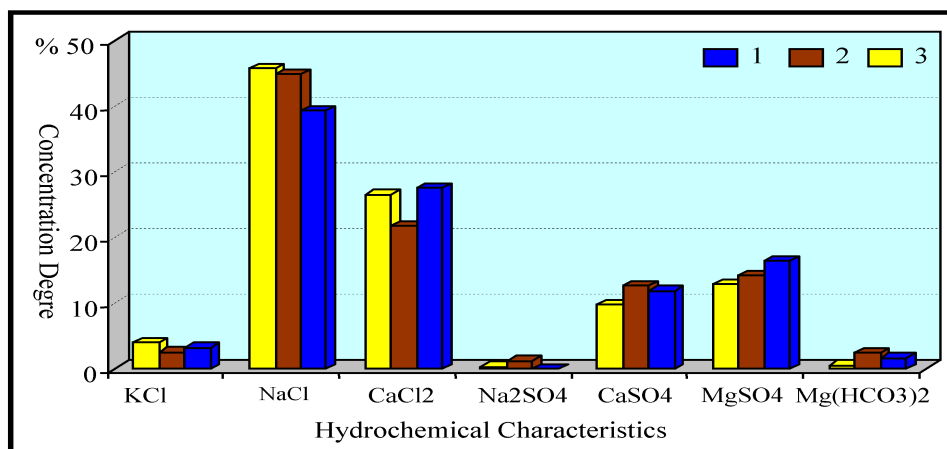
As indicated by the hydrochemical analysis of stone samples (Appendix 1 and Figure 14), there is a presence of chloride salts such as the following: potassium chloride, calcium chloride and sodium chloride salt. The sodium chloride concentration degree ranged between 39.3% and 47.9%, followed by calcium chloride between 25.5% and 31.8%, then chloride potassium by not more than 4.6%.

**Figure 14:** Hydrochemical Characteristics of Stone Samples in Sabil Muhammad Ali

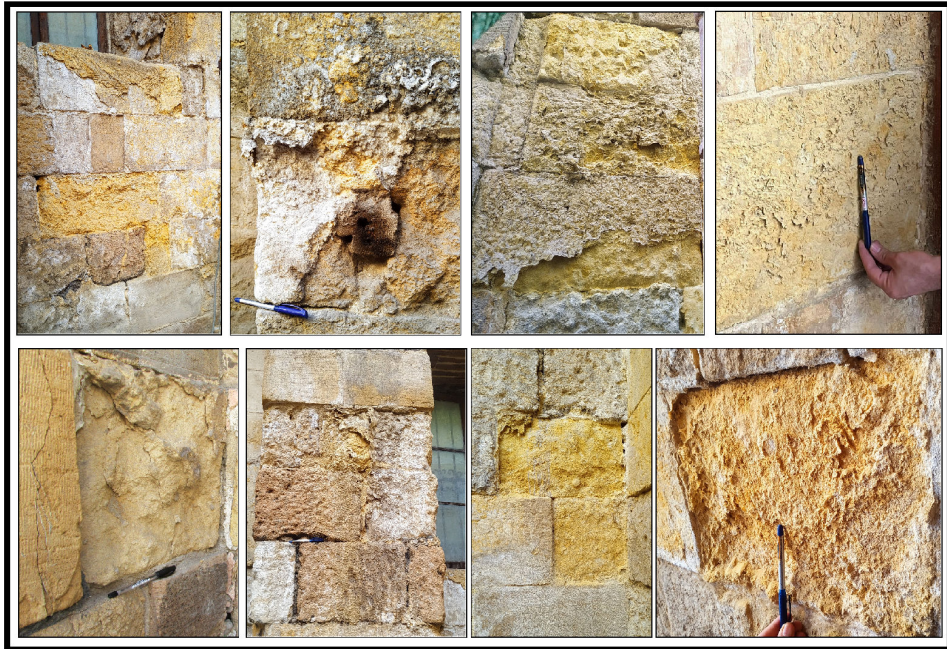
The phenomenon of flaking and fragmentation spreads in Sabil Muhammad Ali (Figure 16), where a contour flaking occurred, with a thickness ranging between 0.5 and 4 mm. This is due to the spread of sulphate salts, particularly sodium sulphate salts in the limestones, where the volume of sodium sulphate salts increases by 300% and pressures occur on the walls of the pores of the stone blocks, leading to destructive hydration stresses to the environment of the stone and the occurrence of its flaking and fragmentation (Abdulhadi et al., 1996). This also occurs when the magnesium sulphate salt crystallizes behind the surface of the stone, causing it to flake and detach, as the magnesium sulphate salt causes damage and corrosion of the building materials used in the construction of Sabil Muhammad Ali, about 35% more than what is caused by the different phases of the sodium sulphate salt during the crystallization cycles of this salt. The magnesium sulfate salt is considered one of the fastest salts in the process of hydration, as the process of hydration of this salt takes place within 6 hours when exposed to moisture, while the process of hydration of sodium sulphate salt may take several days to complete (Hamida, 2003). The limestones with which Sabil Muhammad Ali was built were severely affected by the salt weathering process (crystallization of salts), which appears in the form of granular fragmentation, cracks, potholes and flakes in the limestone fabric. This caused severe fragmentation and erosion in the limestone fabric, which led to erosion or contour retraction in many stones (Figure 16). In the case of continuous damage and lack of maintenance and restoration of this deterioration, the sabil will be exposed to more erosion and danger.

**Figure 16:** The Spread of the Phenomenon of Flaking and Fragmentation in the Stones of Sabil Muhammad Ali

7.2.5) Carrying out periodic maintenance and restoration, speeding up its implementation, and dealing with the manifestations of damage in its early stages, so that the sabil is not exposed to erosion and the loss of its historical and archaeological value.

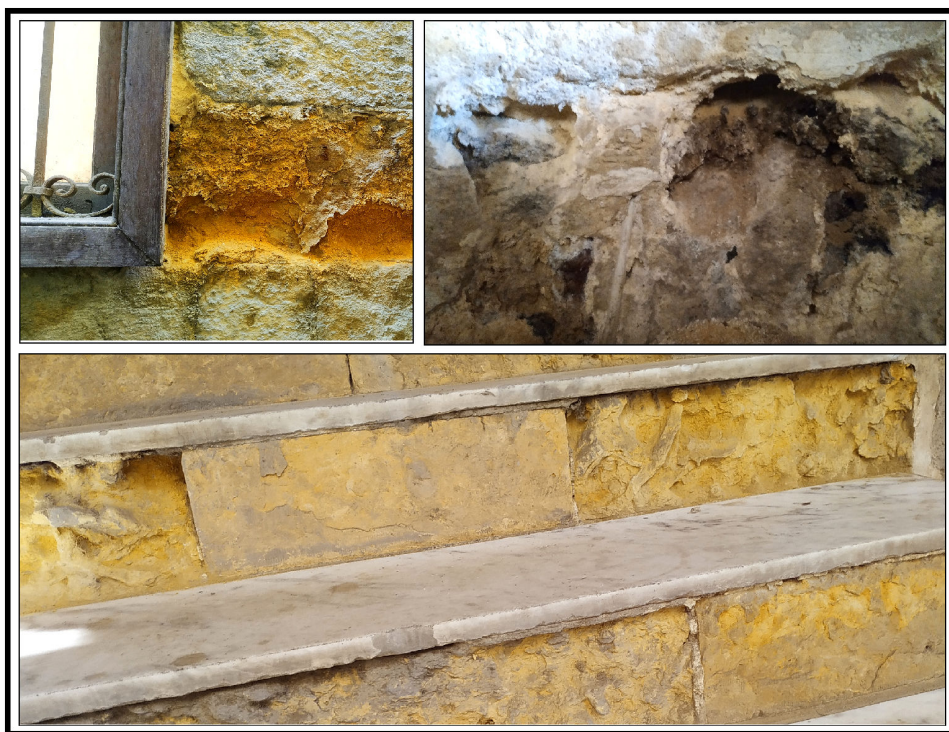
This phenomenon is widely spread in Sabil Muhammad Ali (Figure 17), where irregular erosion of stone surfaces was observed with the formation of voids or cavities of different sizes, along with the formation of gaps connected to each other, in a form resembling honeycomb and Tafone pits. This phenomenon spreads in internal and external surfaces, and at the entrance to the reservoir (cistern), with average diameters ranging between 0.5 and 7.0 cm, and a depth of more than 5 cm in some stones. This, in turn, confirms that the sabil has reached a high level of deterioration. One of the main reasons for the spread of this phenomenon is the presence of sodium sulphate salts; they grow in one direction to take the prismatic shape, which increases their destructive force to the building stones due to the increase in size and its solubility. Moreover, the presence of these gaps is due to the susceptibility of calcium sulphate, whether present on the stone surface

or inside it, to dissolve and be displaced by rainwater, noting that the successive sedimentation and dissolution cycles of salts lead to deepening these gaps more and more.

**Figure 17:** The Spread of Potholes and Gaps in the Stones of Sabil Muhammad Ali

7.2.3) Protecting buildings from the impact of rainwater and making the necessary connections to connect this water to

drainage directly so as to prevent it from collecting near or on the sabil surface.

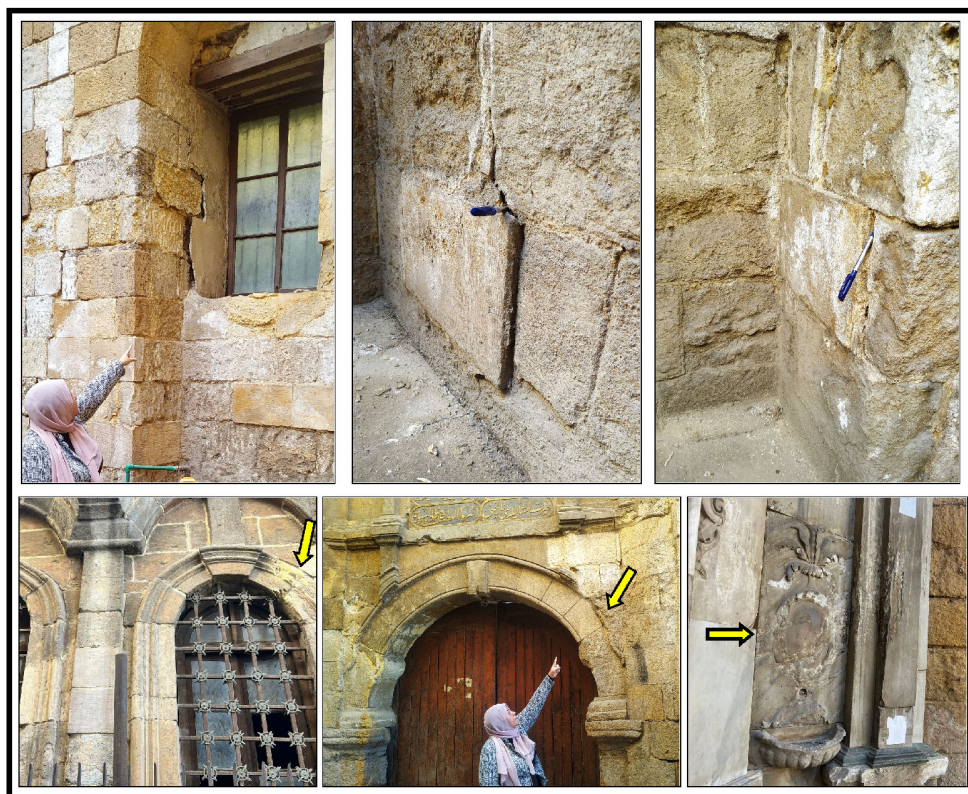
**Figure 19:** The Detachment and Falling of Stone Blocks, Decorations and Ornaments in Sabil Muhammad Ali

7.2.4) Changing worn-out stone blocks with new ones of the same type as the old stone.
